Post-Closure Inspection and Monitoring Report for Corrective Action Unit 417: Central Nevada Test Area Surface, Hot Creek Valley, Nevada, for Calendar Year 2007

September 2008

**U.S. Department
of Energy**

Office of Legacy Management

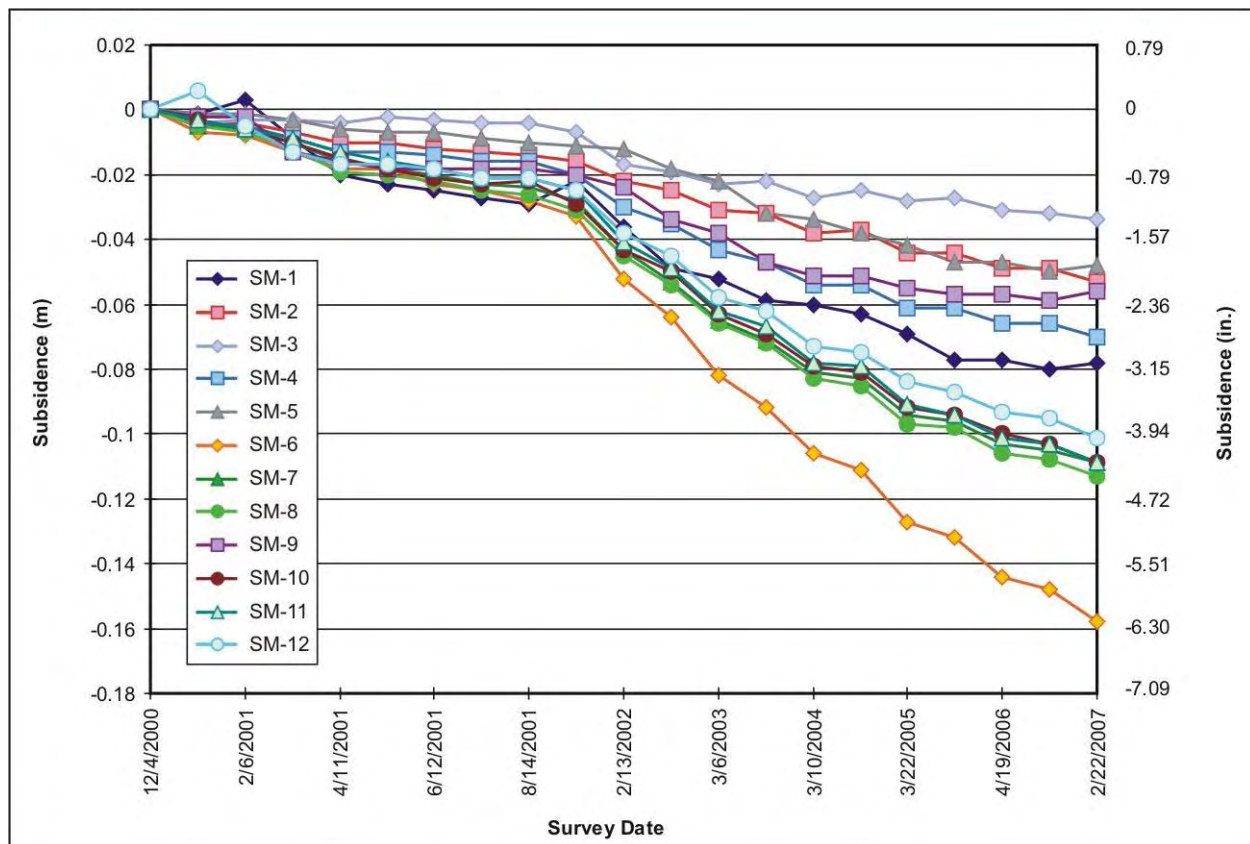
Figure 3-1. UC-1 Cover Settlement

The degree of settling in both the relocation trench and the CMP is within the predicted range and shows no unusual subsidence. The data collected over the CMP section of the cover indicate that the largest subsidence is located along the centerline of the CMP, including SM-6, SM-7, and SM-8. This was expected because of the thicker layer of underlying mud in this area. The northern monuments, SM-2, SM-3, and SM-4, along with the western-most monument, SM-5, show the least subsidence because of the thinner layer of underlying mud along this margin of the cover. The greatest degree of settling continues to be on SM-6, which has subsided a total of 15.8 cm (6.2 in.) since the baseline survey in December 2000.

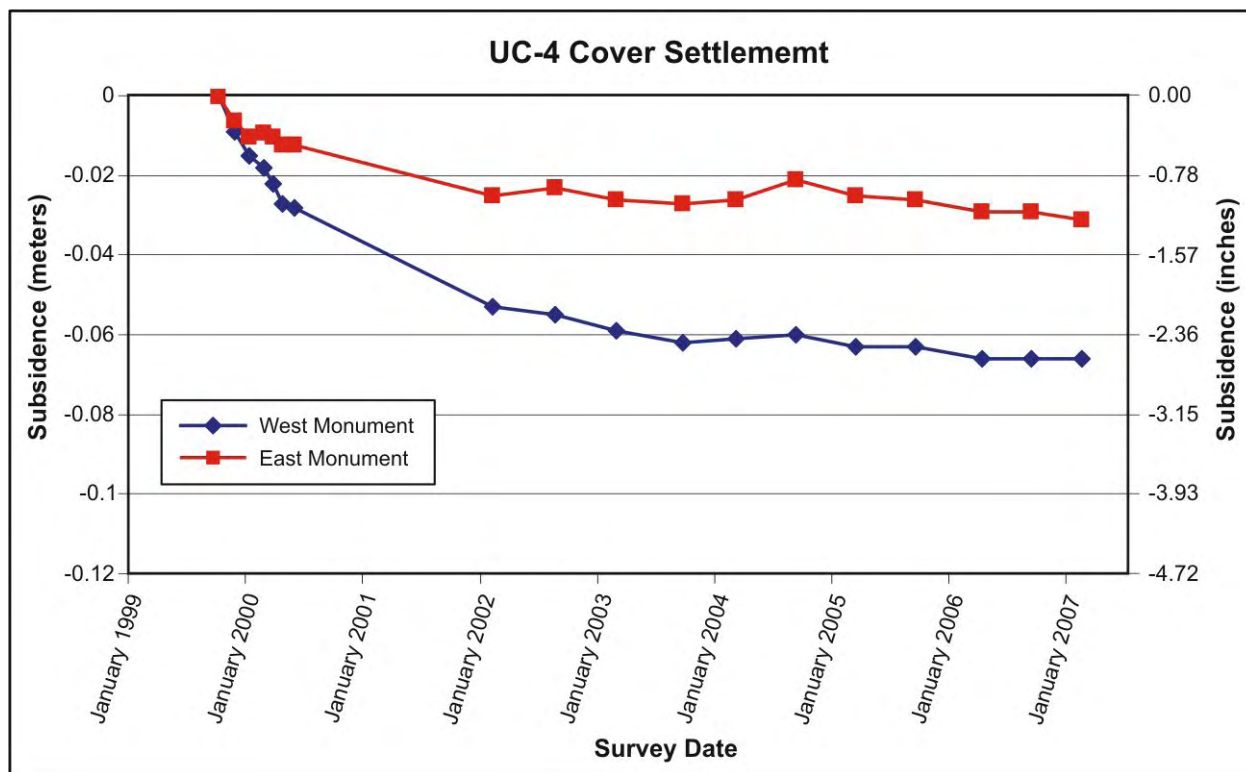
Figure 3–3. UC-4 Cover Settlement

Two permanent SMs (west and east monuments) were installed in the cover to provide elevation control for measuring the subsidence of the cover. These SMs are shown on Figure 3–2. The baseline subsidence survey was completed on October 12, 1999, and is used as the reference survey to calculate subsidence. The UC-4 baseline survey locations and all elevations are provided in Table 3–2 and are presented in graphical form in Figure 3–3. Settling of the west monument is still slightly greater than the predicted settling of 5 cm (2 in.); the total subsidence is 6.6 cm (2.6 in.) since the baseline survey in October 1999. The east monument has subsided a total of 3.1 cm (1.2 in.) since the baseline survey. The largest changes occurred within the first year.

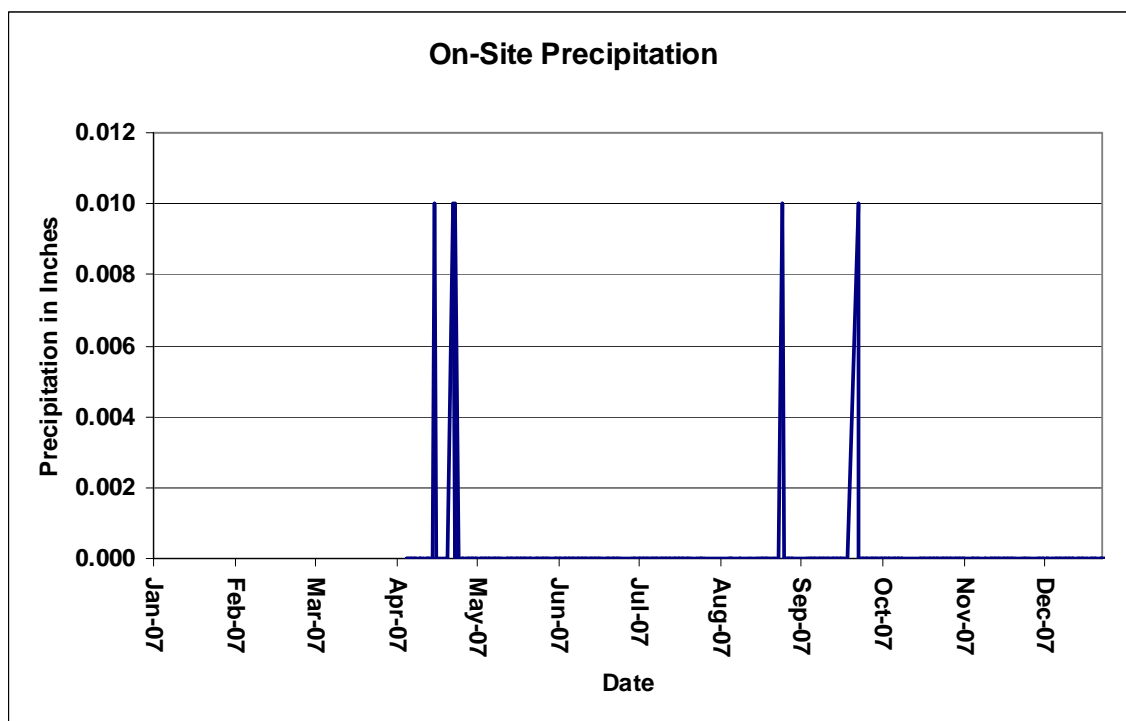
Figure 3–4. 2007 Precipitation Data

The precipitation record for the UC-1 CMP cover is presented in Figure 3–4. Precipitation during 2007 was below average; the April through December rainfall total was 3.23 centimeters (1.27 inches). A summary of the results is provided in the following sections.

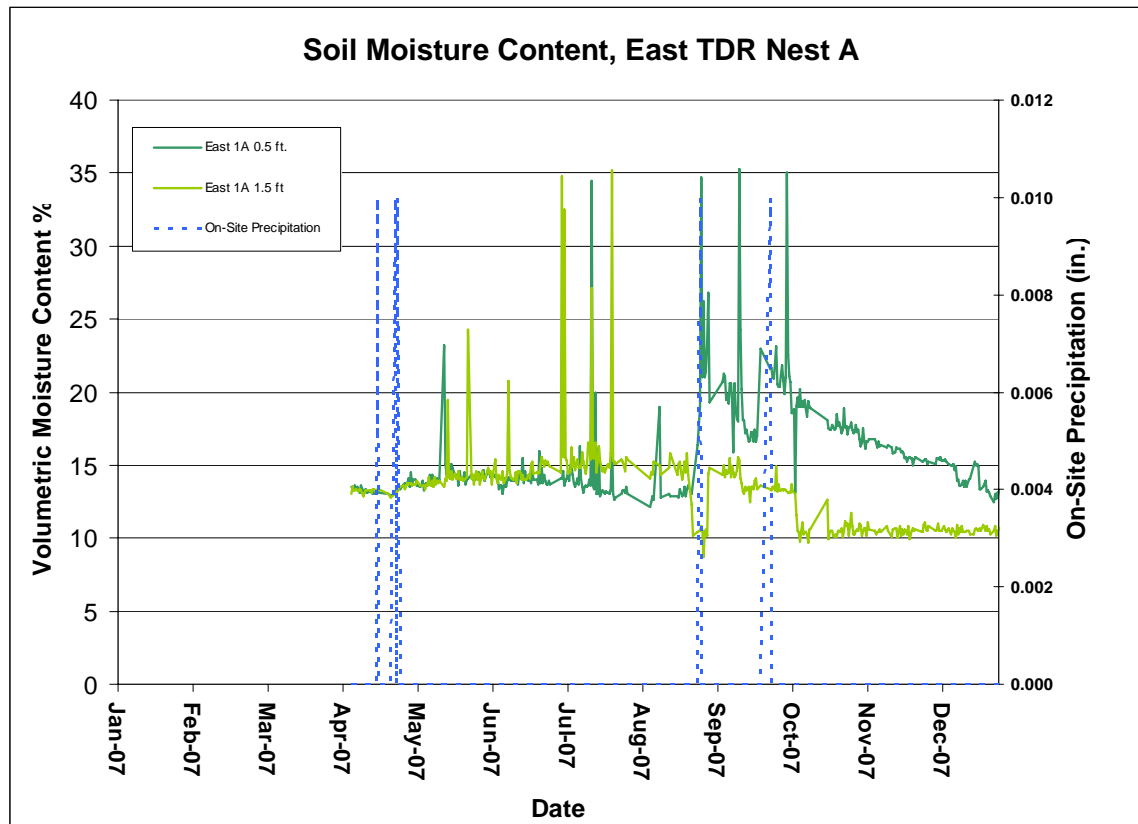
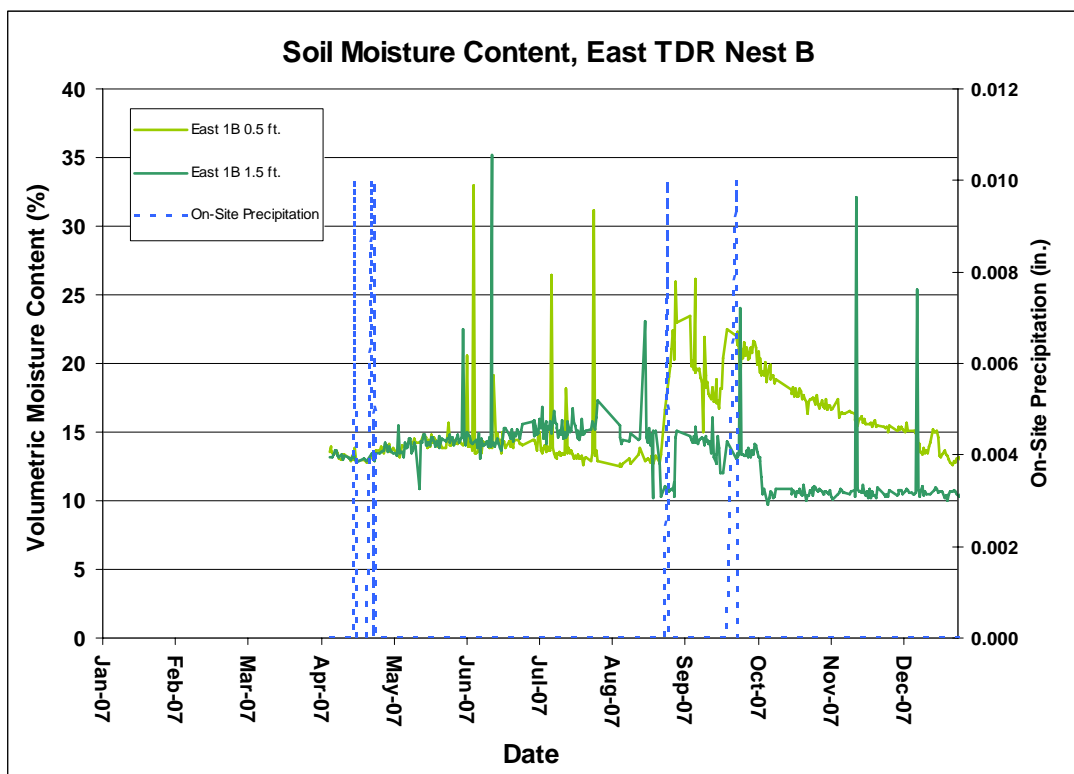
TDR data obtained for the east nests for the 0.76- and 1.07-meter (2.5- and 3.5-ft, respectively) depths were entirely corrupted from an unknown cause. Previously, the long cable length created a problem in measuring the reflected signal from the TDR probes (NNSA/NV 2007). As a result, the data are very noisy and are missing entirely at the 0.76-m and 1.07-m (2.5-ft and 3.5-ft, respectively) depths for both east nests. Inappropriate signal responses from the two TDR stations at depth in the east TDR nest make interpretation of the data difficult. Only the upper two depths are presented on the respective graphs, and from those profiles it is difficult to assess performance of the cover.

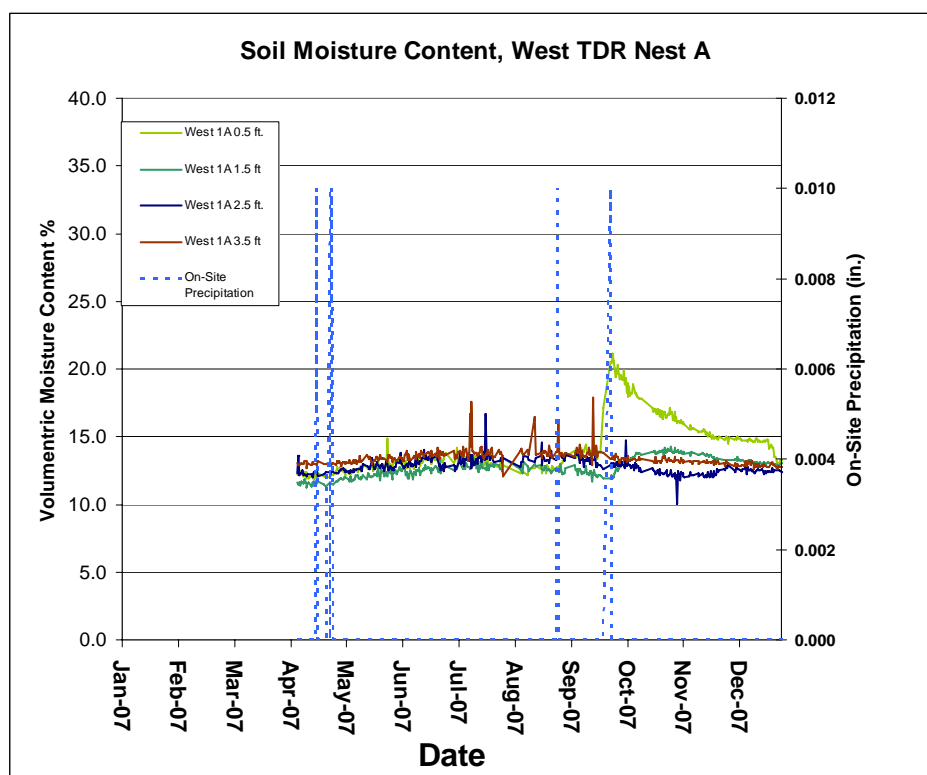
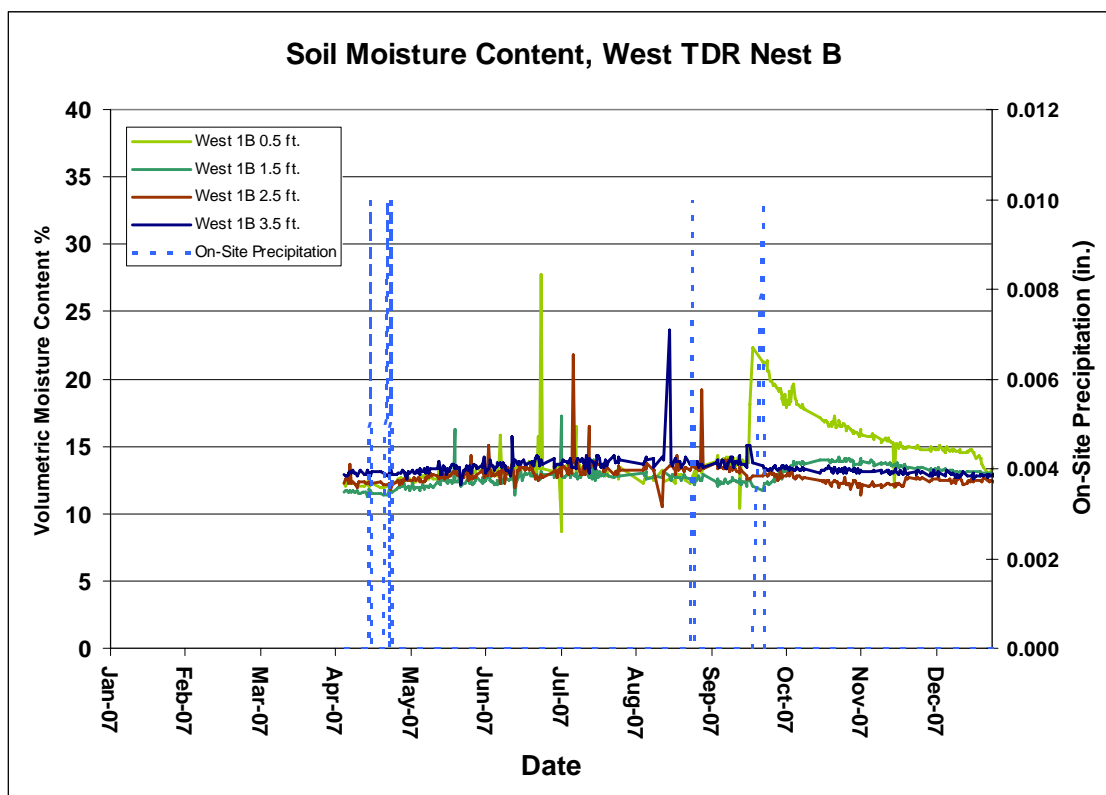
Moisture content measurements indicate steady-state conditions throughout the year until mid-September, when moisture profiles of the near-surface depths increased. Overall, both nests present similar profiles and indicate the cover is performing as designed, with evapotranspiration effectively removing water from the cover. The moisture content at the two deeper profiles appears to be approaching steady state.

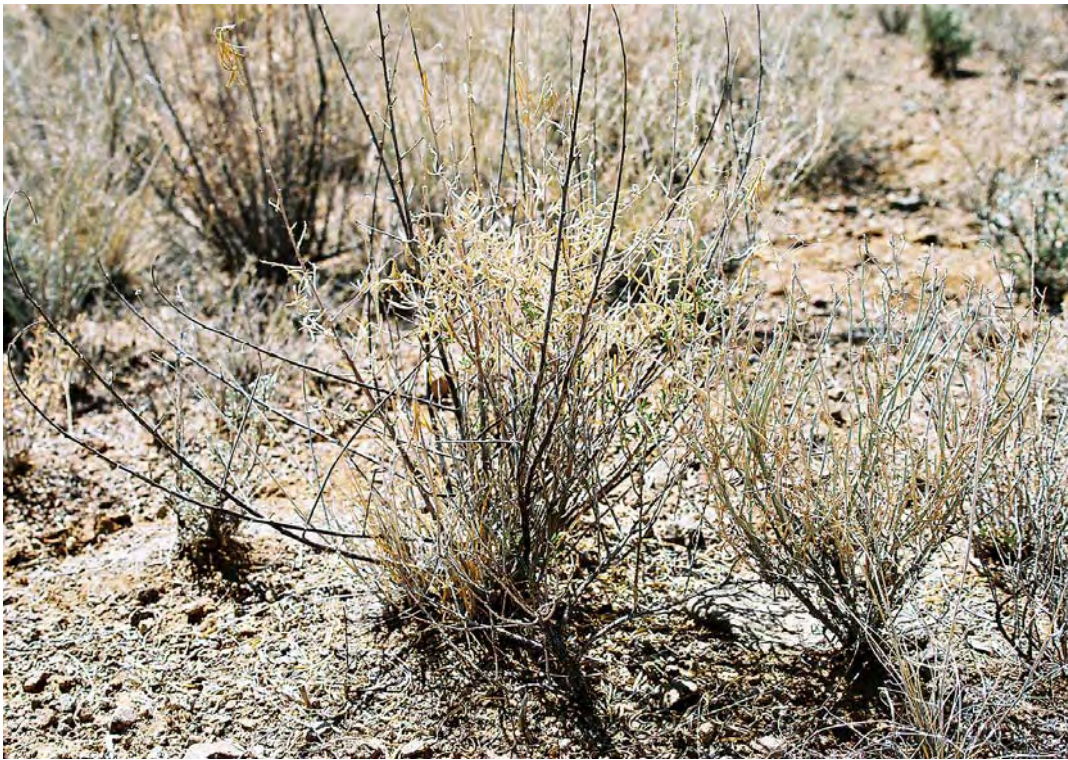
The annual vegetation survey results indicated that approximately half of the Indian ricegrass plants observed within the fenced area appeared to be dormant or dead (i.e., they had not yet sprouted this year's green stems or leaves), and all of the rabbitbrush and fourwing saltbush plants had only begun to show evidence of new spring growth. Sagebrush plants did not show as much stress and appeared healthy. Average total plant cover on the CMP cover was estimated at 18 percent.

Photograph 1: Fourwing saltbush and rubber rabbitbrush plants showing drought stress.
